Energy Audit

*The Janzen House
146 W Spring St.
Marquette, Mi 49855*

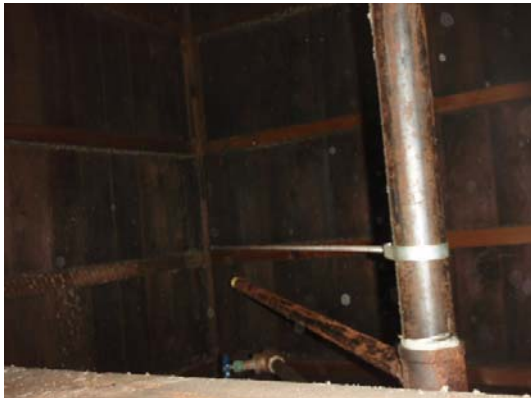
Attic did not have an access panel, however, several locations with large gaping holes which would contribute to warm air rising in the attic, causing snow to melt off of roof deck, and icicles would form at the eaves. **Prior to insulating and air sealing the attic, consult with fire protection system installer to make sure unit will function in attic with freezing temperatures.**

Fire suppression system in attic

The above improvement analysis report is based on adding sidewall insulation, adding attic insulation, air sealing attic and ceiling below, installing proper attic access, and reducing overall air infiltration in the building by 25%. **Before insulating and air sealing the attic, it is important to contact the fire suppression system installer and verify system can be in freezing temperatures.**

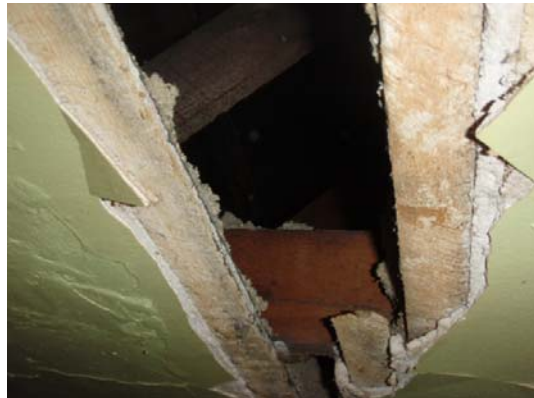
One of several holes above suspended ceiling

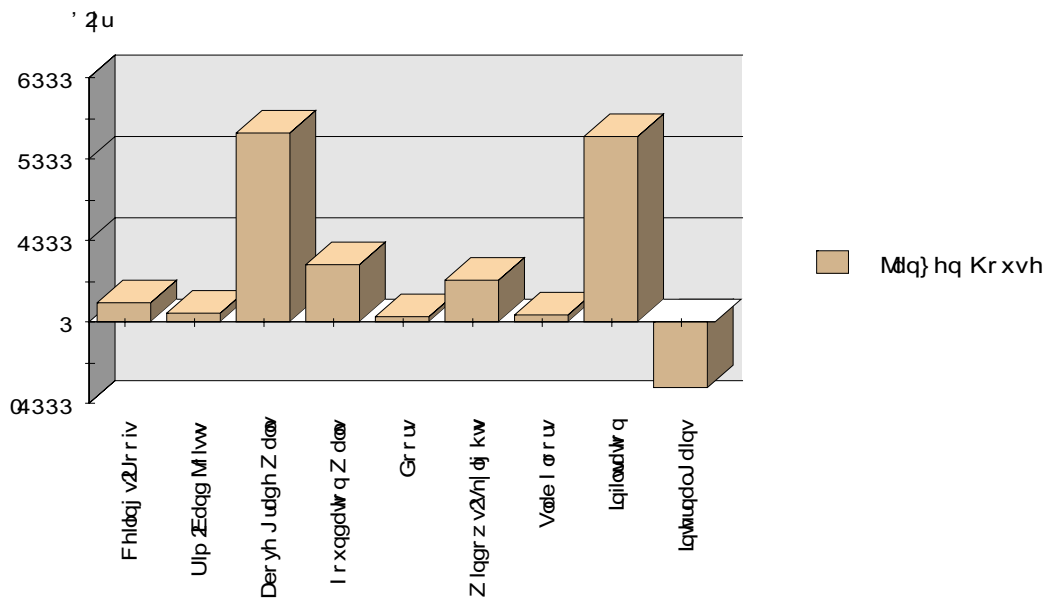
As the above graph indicates, above grade walls and infiltration are the two largest inefficiencies of this building. Therefore, we have prepared an improvement analysis to insulate the above grade walls, insulate the attic, air seal and repair the ceiling, add attic access, and do other air sealing measures.

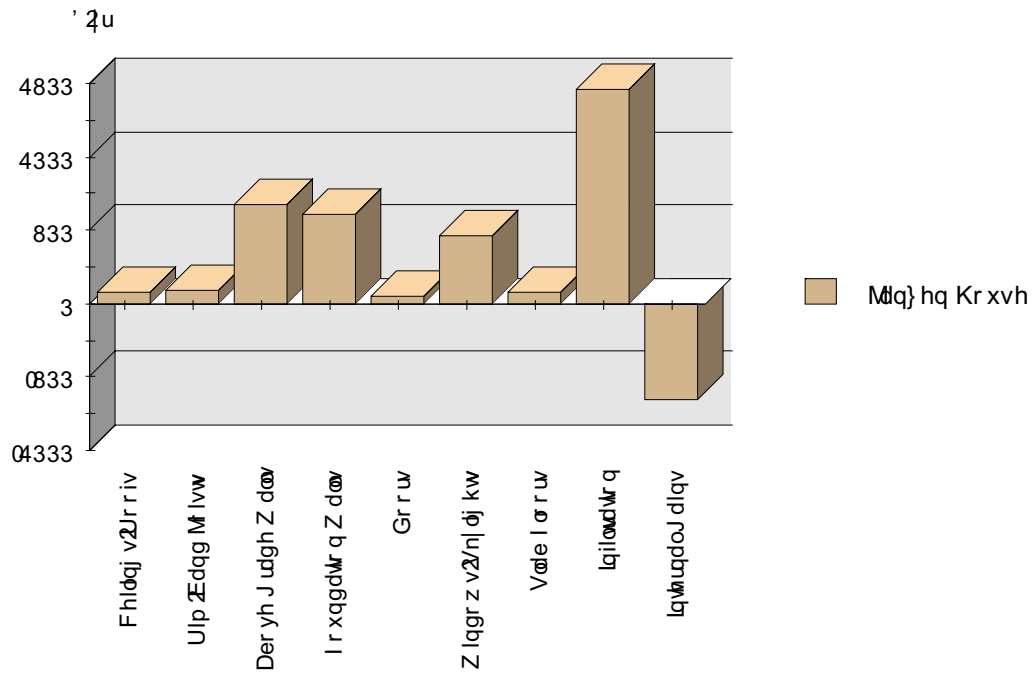
Graph 1 – indicates heating costs will be reduced from \$8379 to \$6215.

This is a graph based on the building improvements, note the difference in building component heat lost from the original graph in this report.
