Energy Audit

*The Janzen House
146 W Spring St.
Marquette, Mi 49855*

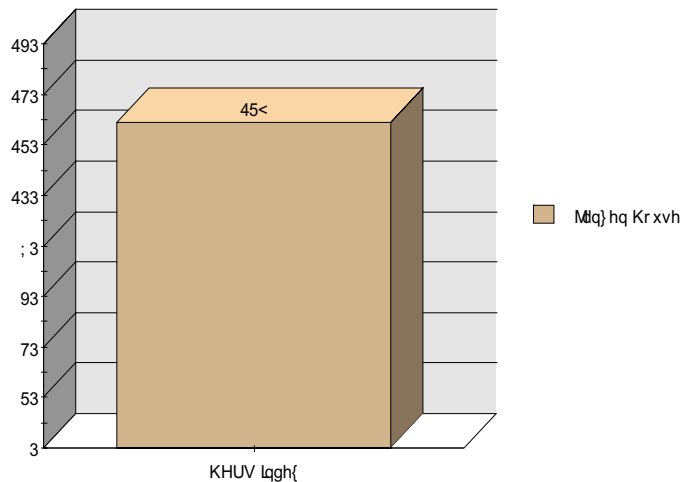
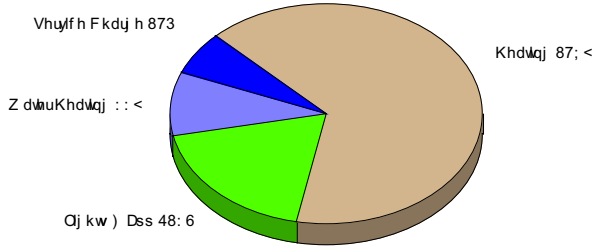
The graph on the upper left suggests annual energy costs. The graph on the upper right is this building in the HERS index. HERS (Home Energy Rating System) is a universal method for rating building performance. A score of 100 (baseline) on the HERS index indicates a building is even with the 2004 IECC (International Energy Conservation Code). A score of 129 describes the building as 29% less efficient than the 2004 IECC.

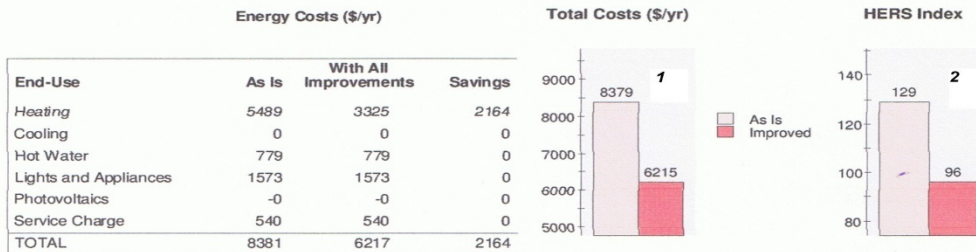
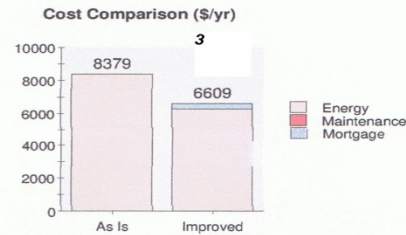
Graph 1 – indicates heating costs will be reduced from \$8379 to \$6215.

Graph 2 – indicates HERS score drops from 129 to 96, a 33% increase in building efficiency!

Graph 3 – indicates that if the money had to be borrowed for the bank for the \$11812 improvements (firm quote must be obtained from insulating contractor), that the building would still have a positive cash flow of \$1770.00 per year.

The above improvement analysis report is based on adding sidewall insulation, adding attic insulation, air sealing attic and ceiling below, installing proper attic access, and reducing overall air infiltration in the building by 25%. **Before insulating and air sealing the attic, it is important to contact the fire suppression system installer and verify system can be in freezing temperatures.**

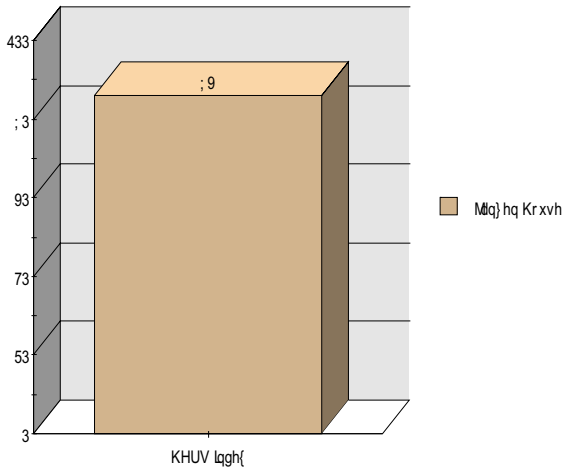
This is a graph based on the building improvements, note the difference in building component heat lost from the original graph in this report.
